# Modularity in Orthopaedics

Professor Michael M Morlock, Institute of Biomechanics, TUHH Hamburg University of Technology, Hamburg, Germany

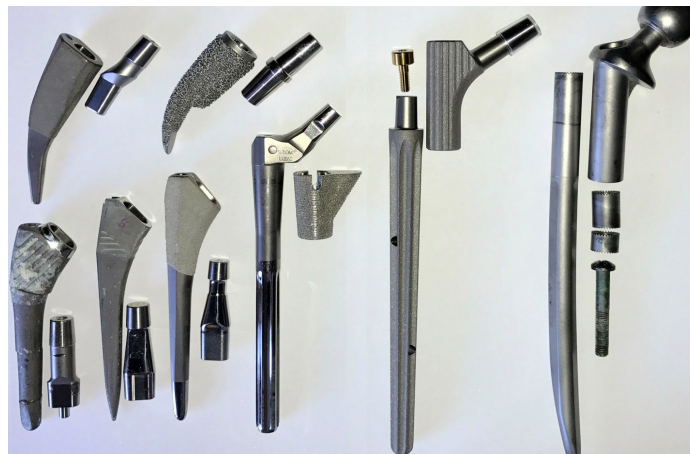
Figure 1: Contemporary primary and revision hip replacement systems with neck modularity

In the early 1990s, 90% of femoral stems in use were modular<sup>1</sup>. It was recognised that the head of an implanted THA is exposed to torque as a result of joint friction, although the difference between the fixation strength and the friction torque was not as great as expected. Nevertheless, assembly and loading is crucial to optimise taper connection strength<sup>2</sup>. Problems with modularity were recognised<sup>2-5</sup>, but despite these problems, designs with additional modular connections such as bi-modular primary stems and modular revision stems were introduced (Figure 1).

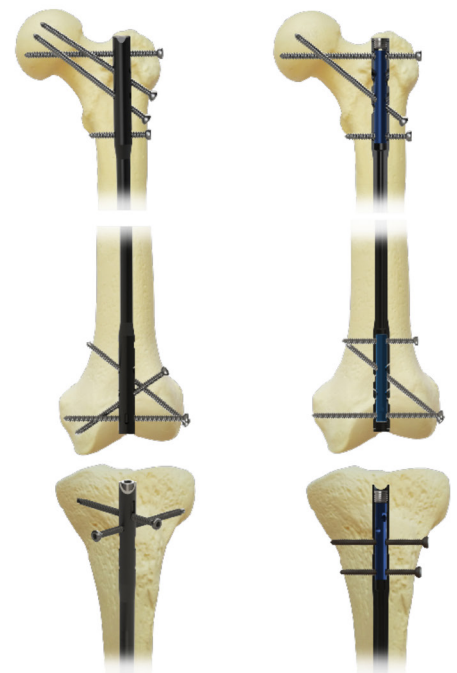
Our CE-marked Apex Tibial Nailing system offers a suite of innovative locking options including micromotion stimulation and best-in-class torsional stability.

Stable

Micromotion

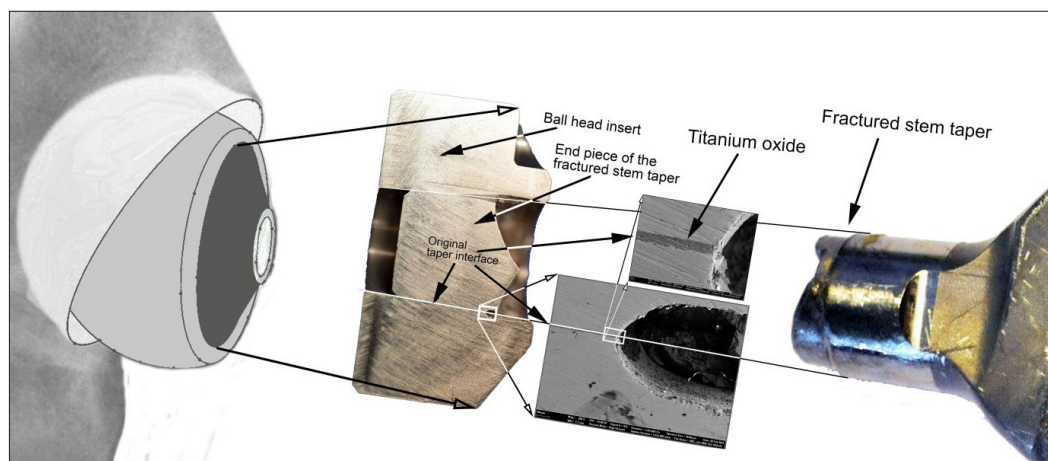
**Figure 2:** Metal-on-metal hip replacement, which was revised due to a fracture of the Ti-alloy stem taper inside the Ti-alloy ball head insert<sup>12</sup>. The original taper interface is indicated in the exploded diagram. The inserts show different magnifications of the corrosion cavity, which is located symmetrically to the taper interface. A 20µm thick Titanium oxide layer at the location of the start of the corrosion process is unknown. The cause for the start of the corrosion process is unknown.

Retrieval studies rely on the detailed description of the observed damage and changes to the implant components (Figure 2). The same damage or change then has to be reproduced in the laboratory, under defined conditions, in order to establish a cause-effect relationship. Finally completing picture using registry is essential, as the registry document the absolute frequency of the problem and averages out surgeon and patient influences.
